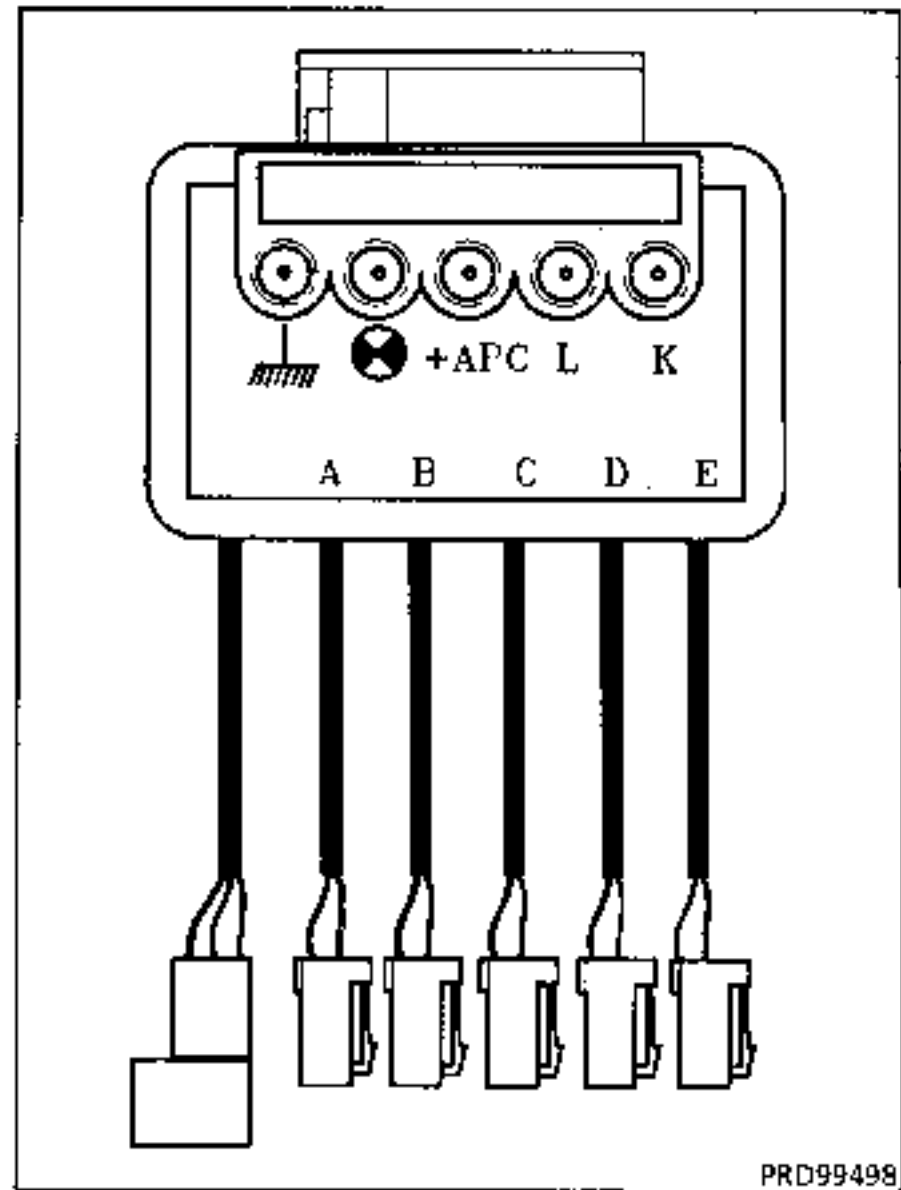
This bornier is connected instead of and in the place of the electronic unit fitted with a unique 30 track connector.
